ON-SITE AIR BAG INVESTIGATION

CASE NO. - 94-18
FLEET - PRIVATE VEHICLE
LOCATION - NEBRASKA
ACCIDENT DATE - 1994

This report concerns a motor vehicle crash involving an air bag equipped 1992 Ford Taurus LX, four-door sedan occurring on 1994 at 11:40 a.m., near Nebraska on a county road. This crash is of special interest because it was alleged that the driver-side air bag had caused severe head injuries to the driver of the case vehicle.

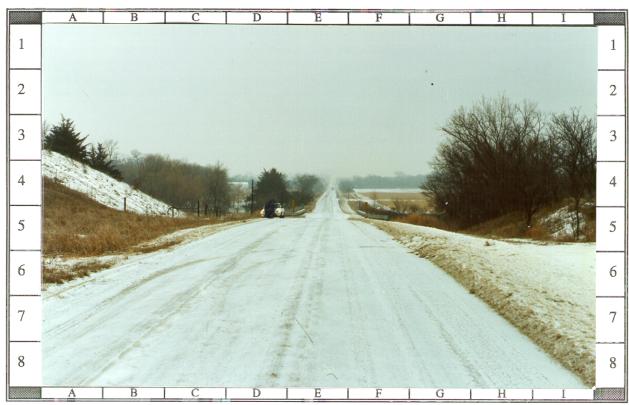
01 -- 1992 Ford Taurus's northward approach on gravel road toward bridge--approximately 100 meters south of guardrail impact

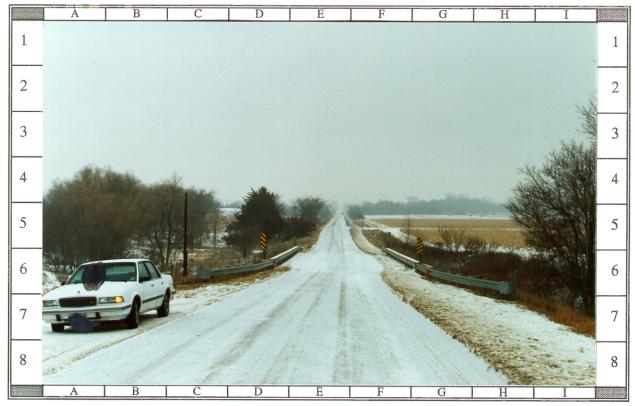
02 -- 1992 Ford Taurus's northward approach toward bridge at ~ beginning of clockwise rotation; NOTE: guardrail impact in cell G6

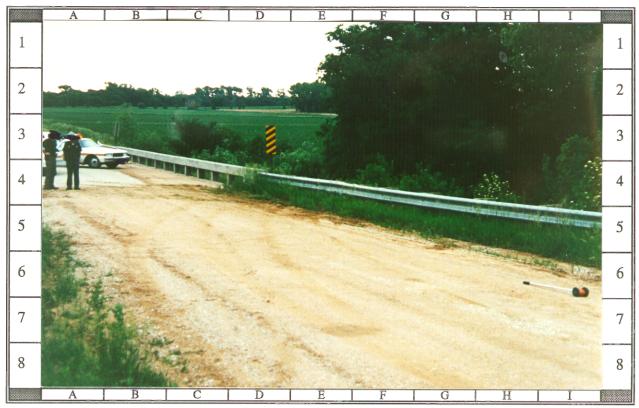
03 -- On scene view, looking NE, of 1992 Ford Taurus's guardrail impact--see cell E4; NOTE: four-tire clockwise rotation scuffs

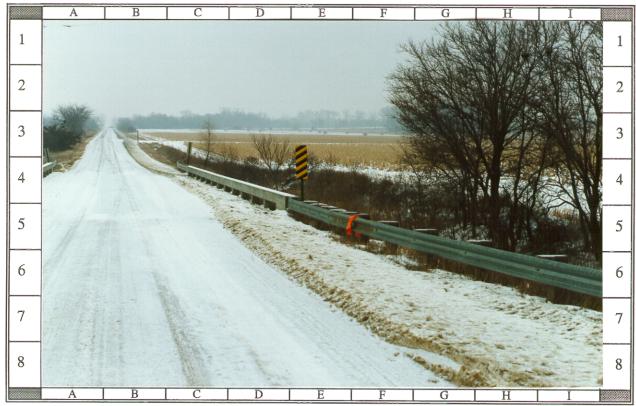
04 -- North-northeast view of 1992 Ford Taurus's guardrail impact--see red flag in cells E5--F5; NOTE: guardrail repaired no evidence

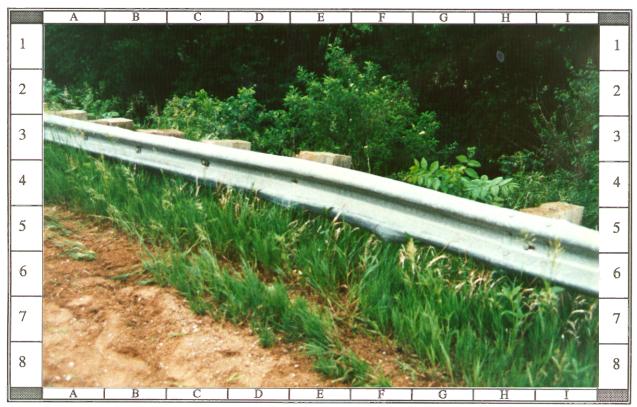
05 -- Close-up on scene view, looking NE, of 1992 Ford Taurus's impact with guardrail (cells D4--F5); see RF tire mark near rail

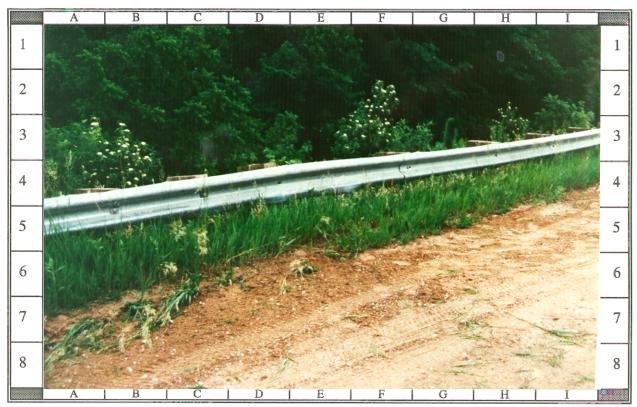
06 -- NE view of replacement guardrail impacted by 1992 Ford Taurus; NOTE: in Photo #05 above guardrail was ripped from holding pin

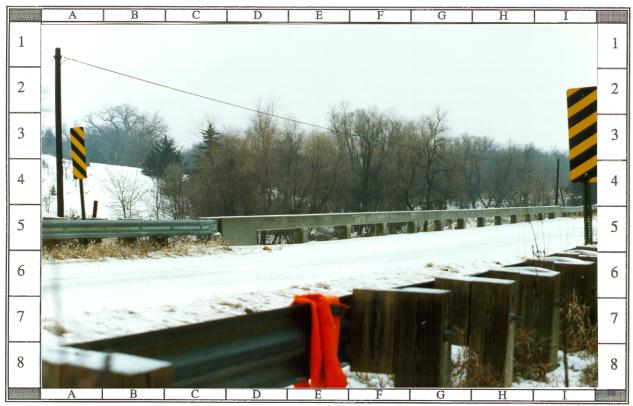
08 -- Northwest view of 1992 Ford Taurus's post-guardrail impact direction of travel onto bridge from behind replacement guardrail

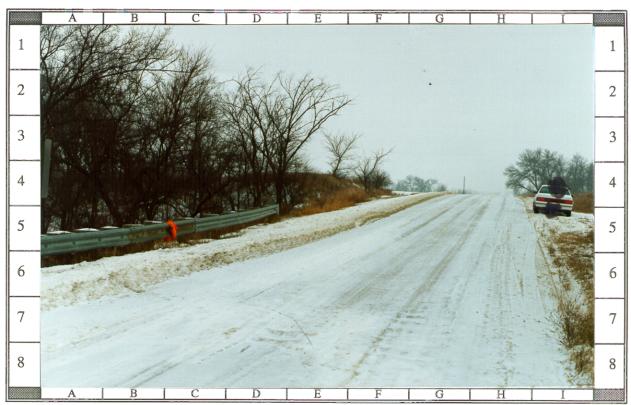
09 -- South-southeast view of 1992 Ford Taurus's ~ initial rest area prior to Taurus's south-southeast movement toward east roadside

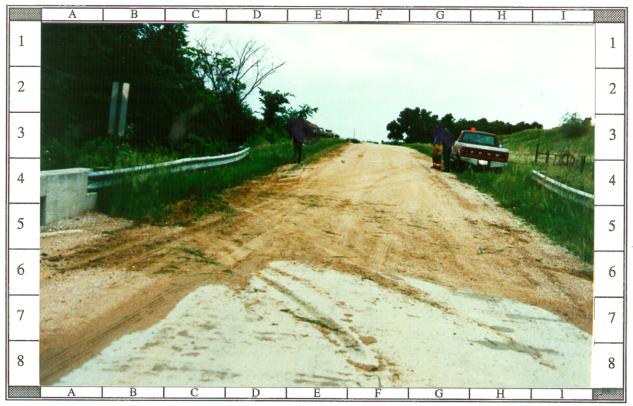
10 -- On scene view, looking south, of '92 Ford Taurus's post-guard-rail impact CW travel to initial rest area; NOTE: tire marks

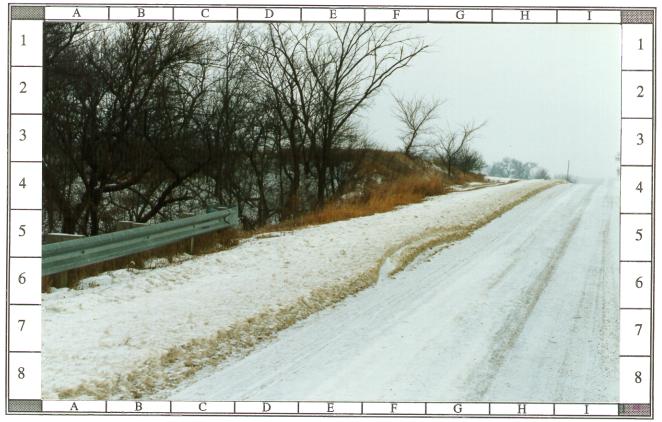
12 -- South-southeast view of 1992 Ford Taurus's path of travel just prior to departing E side of road & going down steep embankment

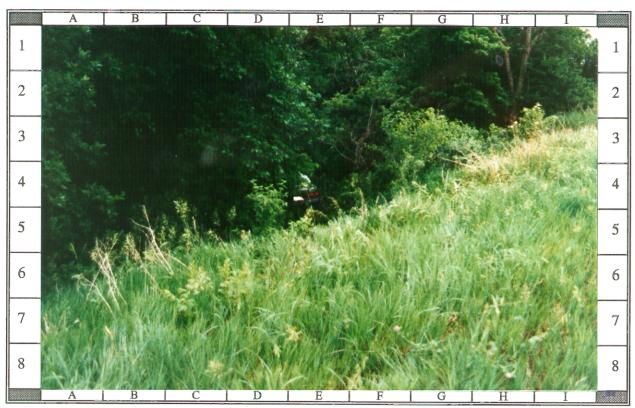
13 -- On scene view, looking E-SE from east roadside, of 1992 Ford Taurus's final rest position at bottom of embankment

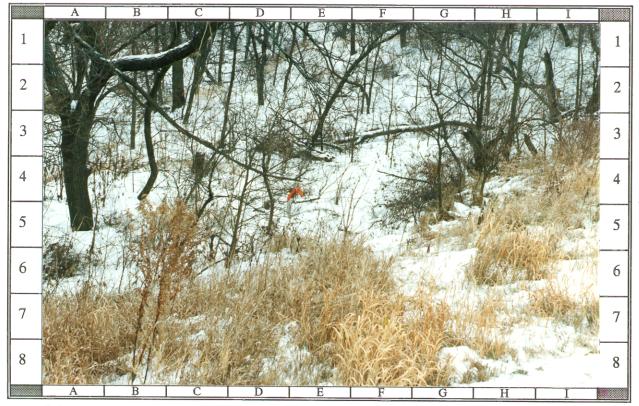
14 -- East-southeast view from E roadside of '92 Ford Taurus's ~ final rest position (red flag) at bottom of embankment--see cell E4

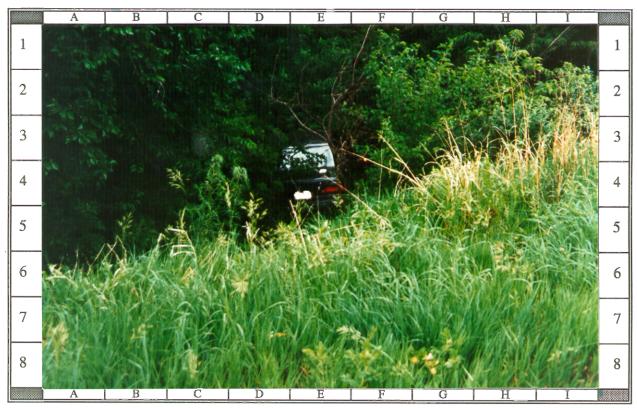
15 -- On scene view, looking E-SE from mid-point of E embankment, of 1992 Ford Taurus's final rest position at bottom of embankment

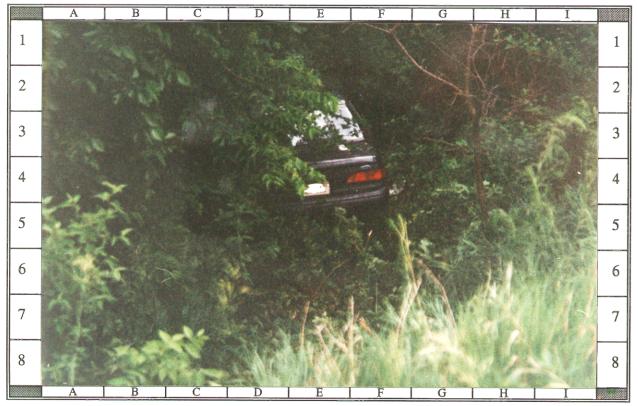
16 -- Close-up on scene view, looking E-SE, of '92 Ford Taurus's FRP at bottom of embankment; NOTE: tree & limbs (see cells F1--H5)

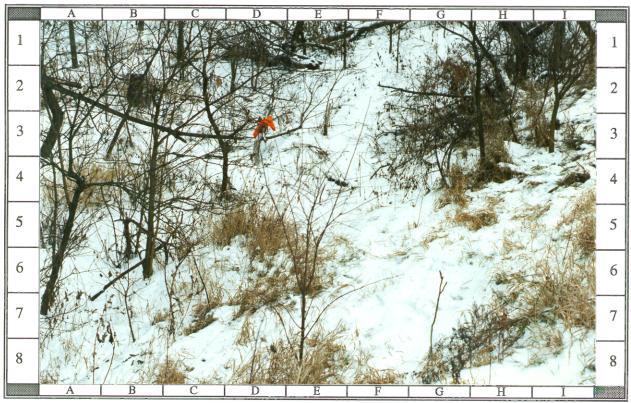
17 -- E-SE view from midpoint of E embankment of 1992 Ford Taurus's ~ FRP at bottom; compare tree & limbs (cells G1--H4) in photo #16

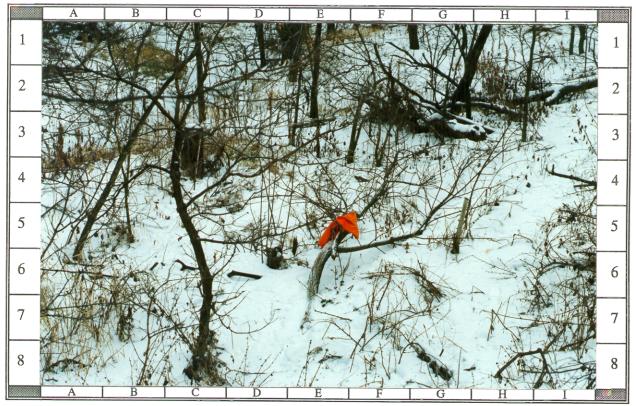
18 -- Close-up of 1992 Ford Taurus's ~ FRP at embankment bottom heading E-SE; cell G8 shows embankment impact that deployed air bag

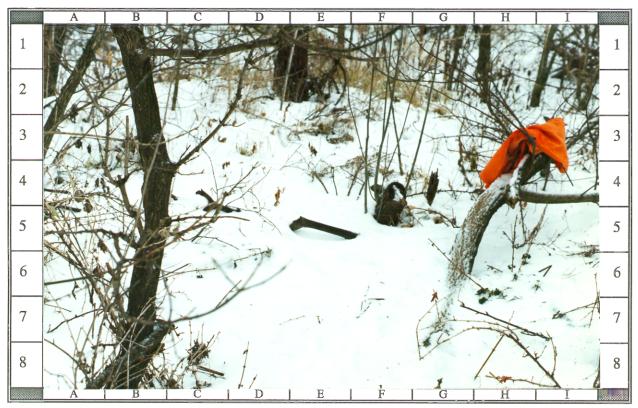
19 -- Closer-up of 1992 Ford Taurus's ~ final rest position at bottom of embankment heading east-southeast; NOTE: no contact to tree

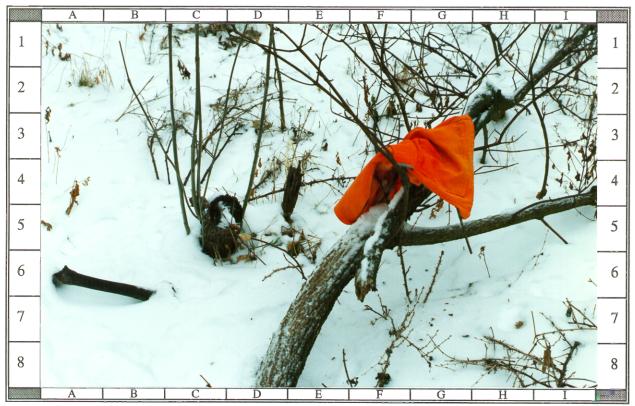
20 -- Closest-up of 1992 Ford Taurus's ~ final rest position at bottom of embankment heading east-southeast; NOTE: no contact to tree

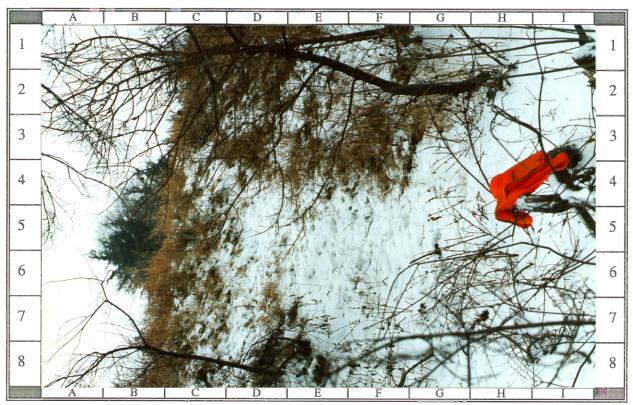
21 -- W-NW view from beyond ~ FRP of '92 Ford Taurus's travel path; see tree & limbs (cells A7--D8) & bag deployment area (cells F5--G6)

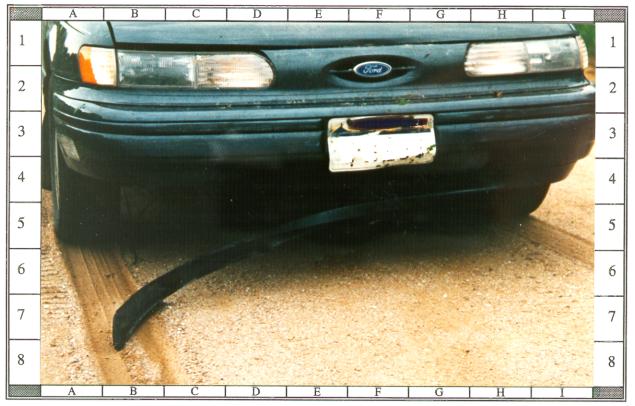
22 -- On scene close-up of 1992 Ford Taurus's damaged front bumper viewed from front--offset R; NOTE: soft sandy nature of roadway

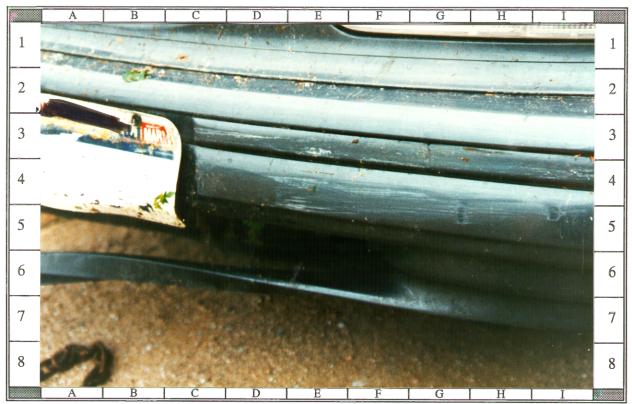
23 -- On scene closer-up of 1992 Ford Taurus's damaged front R bumper viewed from FR; NOTE: damaged air dam & grass above bumper

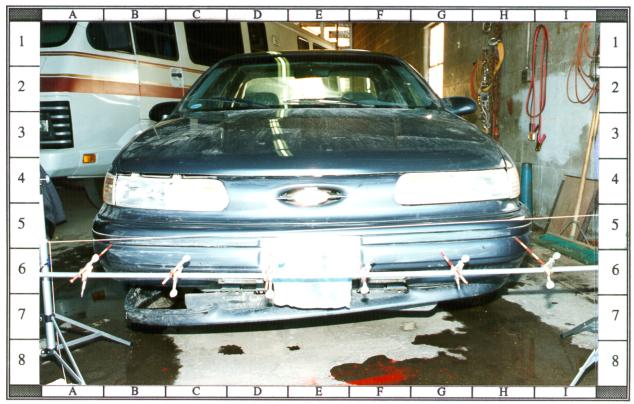
24 -- On scene closer-up of 1992 Ford Taurus's damaged front L bumper viewed from FL; NOTE: damaged air dam & grass above bumper

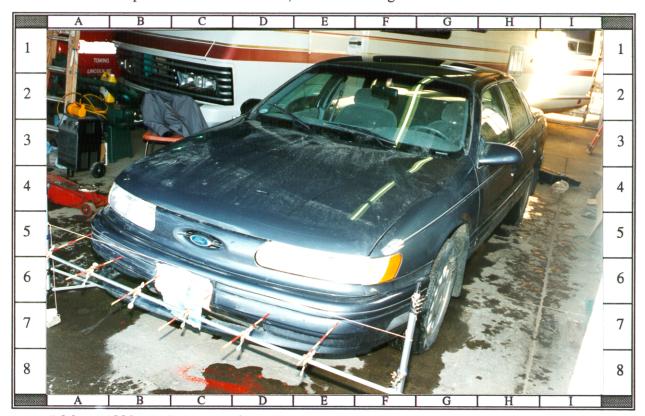
25 -- 1992 Ford Taurus's frontal damage with contour guage present at bumper level viewed from F; NOTE: damage to air dam on R side

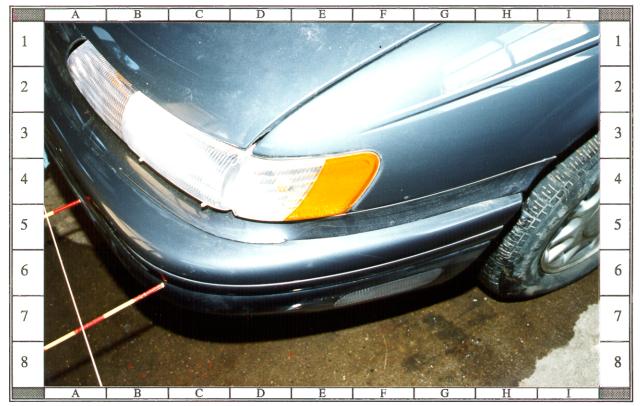
27 -- Close-up of scratches on 1992 Ford Taurus's FL bumper from CW rotational impact with guardrail; NOTE: no LF headlight damage

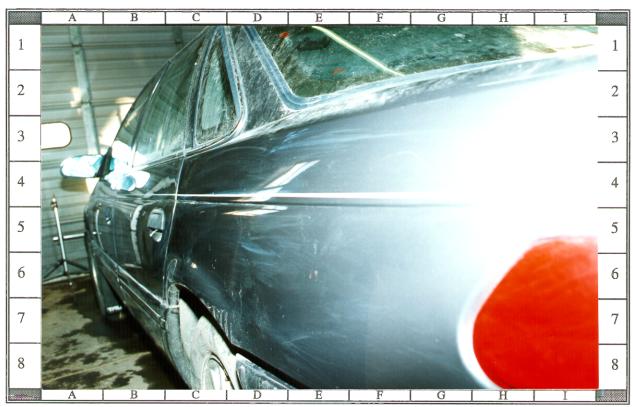
32 -- Close-up of damage to '92 Ford Taurus's L lower driver door area most likely induced from the rearward movement of the LF fender

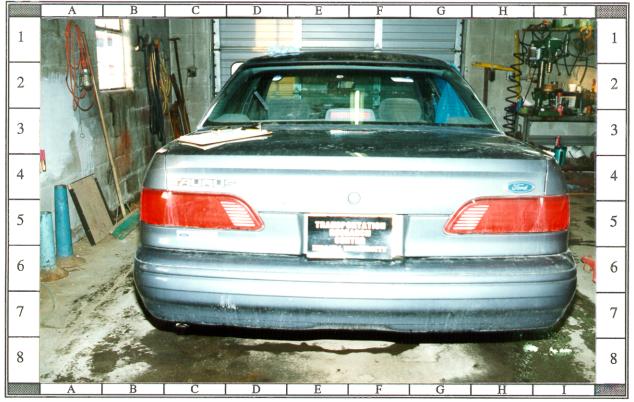
34 -- 1992 Ford Taurus's undamaged rear viewed from rear

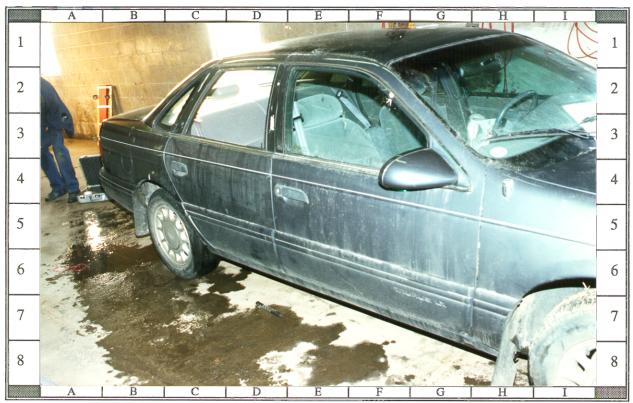
35 -- 1992 Ford Taurus's undamaged right side viewed from right front; right rear window was shattered during extrication of driver

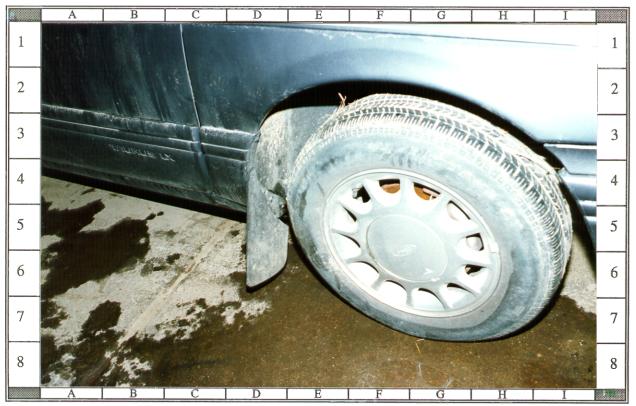
36 -- Close-up of mudflap behind 1992 Ford Taurus's right front wheel; NOTE: damage most likely occurred during travel down embankment

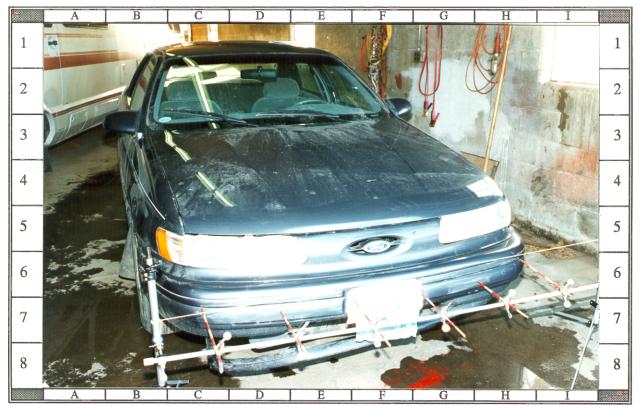
37 -- Front reference line view of '92 Ford Taurus's F bumper damage viewed from R; see scratches from bumper stroke (cells D4--E4)

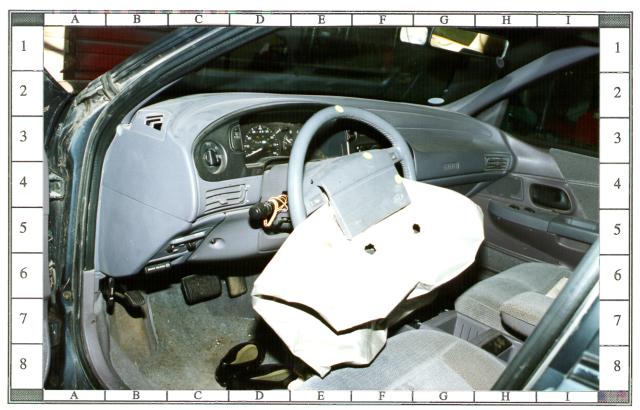
44 -- On scene view of 1992 Ford Taurus's blood-splattered driver air bag; driver was bleeding from face when air bag deployed

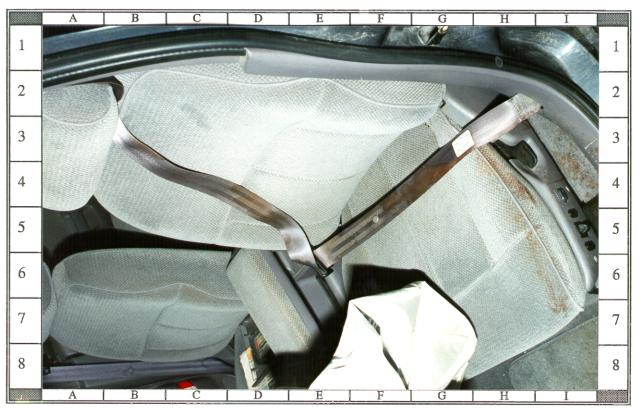
49 -- 1992 Ford Taurus's driver seat showing restraint usage and blood present on seat, belt webbing--both chest & lap, and sill area"

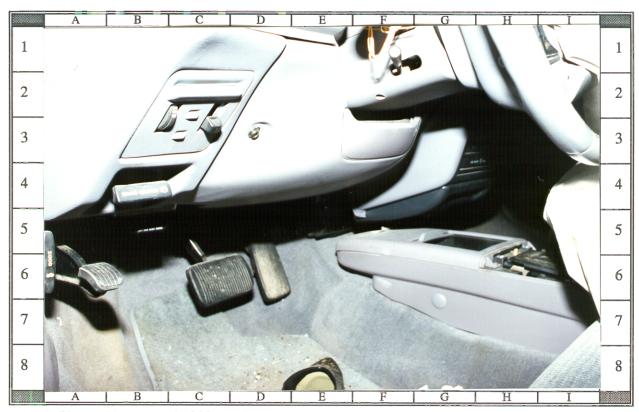
51 -- Close-up of 1992 Ford Taurus's left lower dash area showing no evidence of driver contact

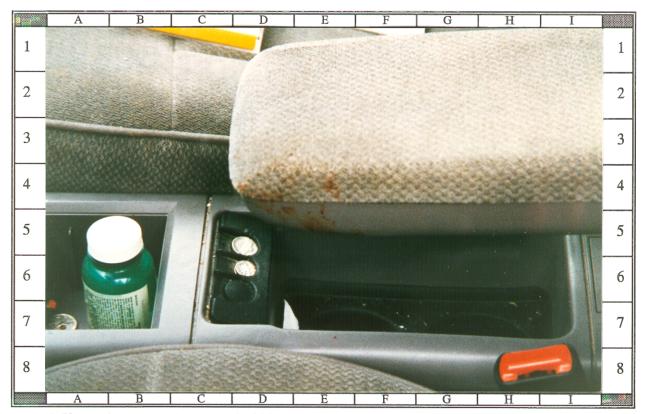
52 -- On scene close-up of 1992 Ford Taurus's blood-splattered centermounted console showing bleeding occurred prior to deployment

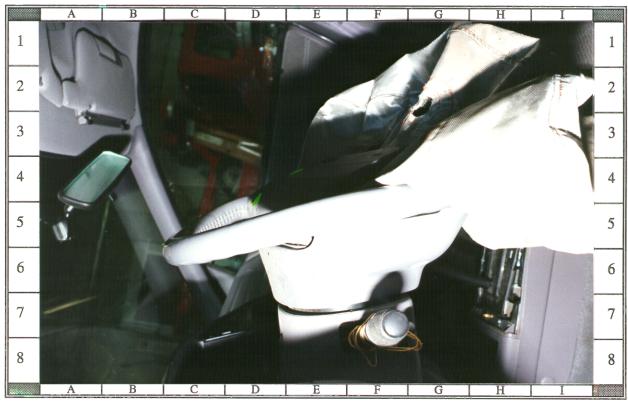
53 -- Close-up of 1992 Ford Taurus's bent steering wheel rim--top of rim moved ~ 2.5 cm; NOTE: no contacts to mirror or RF sunvisor

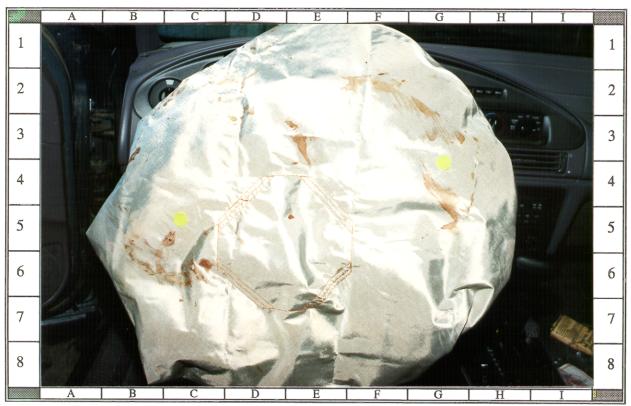
54 -- 1992 Ford Taurus's deployed driver air bag showing blood & contact evidence; NOTE: left yellow dot marks blood & lipstick

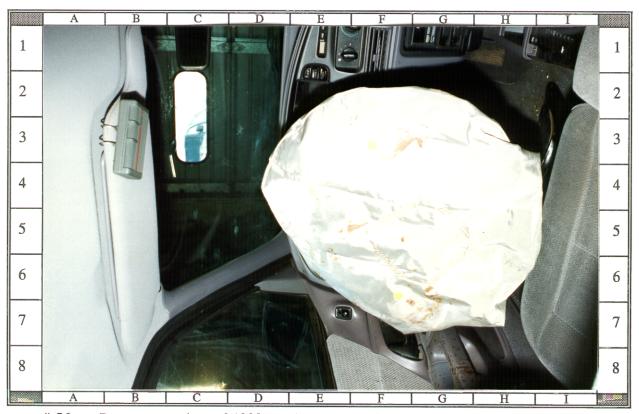
56 -- Rear center view of 1992 Ford Taurus's driver seating area showing deployed air bag, seat, L A-pillar, L sunvisor/header area

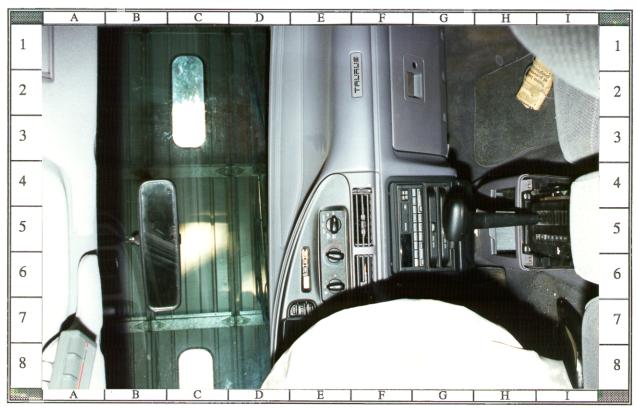
57 -- Rear center view of '92 Ford Taurus's noncontacted rearview mirror, center dash, console, & header, and windshield

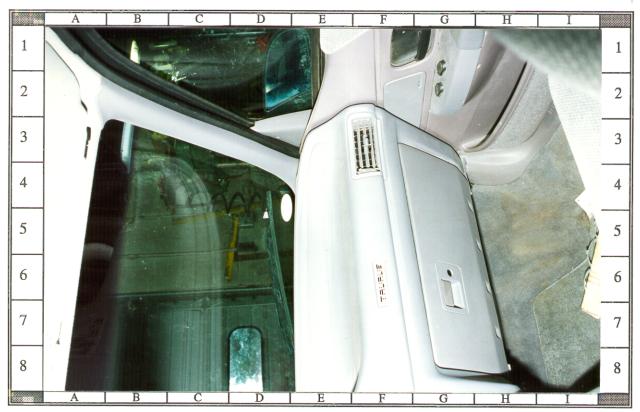
58 -- Rear center view of '92 Ford Taurus's noncontacted right dash

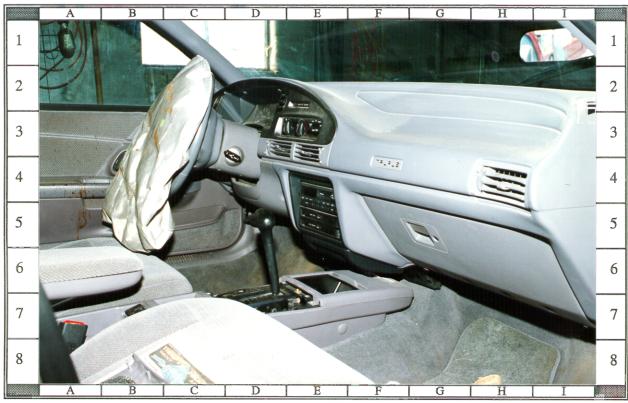
59 -- Front occupant seating area of 1992 Ford Taurus viewed from RF door; NOTE: no evidence of contact to windshield or dash

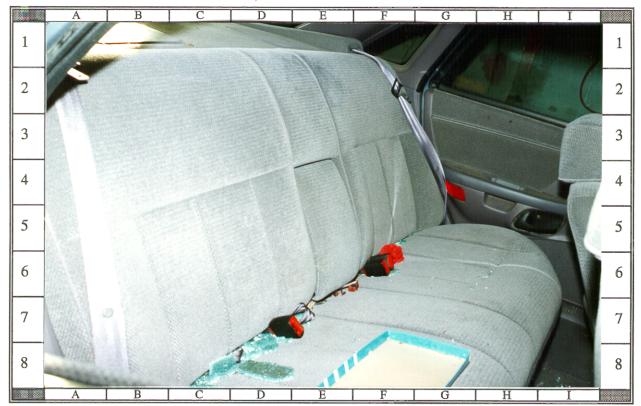
60 -- Rear occupant seating area of 1992 Ford Taurus viewed through RR window which was broken during extrication; NOTE: restraints
